# Manhole Inspection Summary

Manhole # S41E2\_011MH

Insp Date: **12/10/07 12:54 PM**

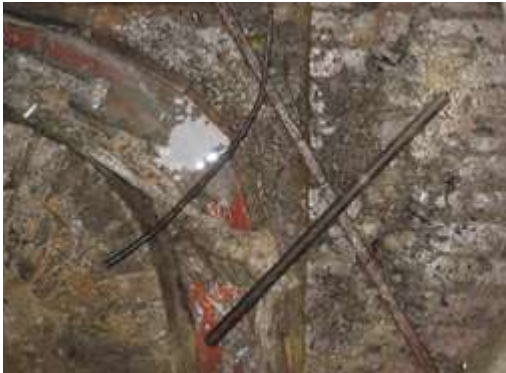
Defect 2

Poles

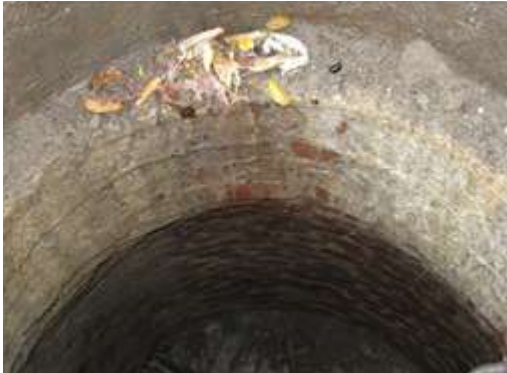
Defect 1

**Frame** Offset: **4** (in.) Condition: ☒ Sound ☐ Cracked ☐ Leaks

Frame offset

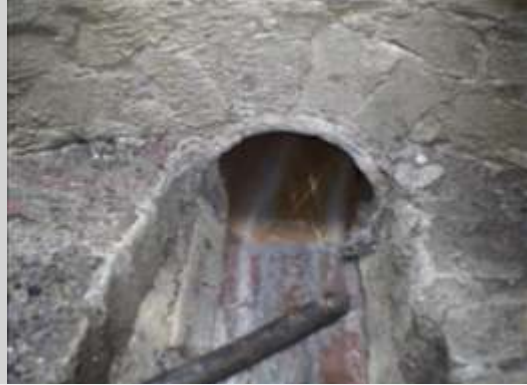
12 O'Clock Outflow

8 in. Circular Gravity Sewer  
Pipe Out @ 12 O'Clock

Pipe Height: **9.6** (in.) Rod and Bar (Angled)  
Pipe Material: **Clay** ☐ Pipe Lined  
Invert Depth: **7.63** (ft.) Flow Characteristics: **Fast**  
Deposits: ☒ None ☐ Mud ☐ Sludge ☐ **Debris** ☐ Grease  
Silt Depth: (in.) Deposits Extent:  
Infiltration: **None** Pipe Seal Cond: **Sound**

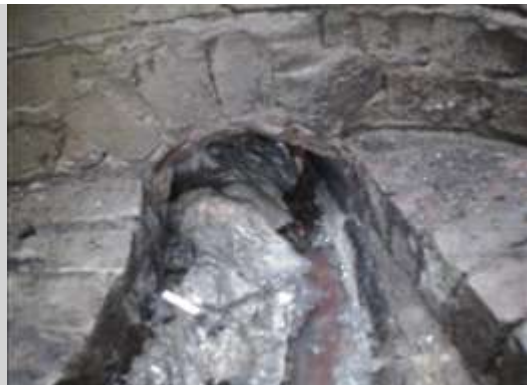
3 O'Clock Inflow

8 in. Circular Gravity Sewer  
Pipe In @ 3 O'Clock

Pipe Height: **8.4** (in.) Rod and Bar (Angled)  
Pipe Material: **Clay** ☐ Pipe Lined  
Invert Depth: **7.47** (ft.) Flow Characteristics: **Slow**  
Deposits: ☐ None ☐ Mud ☐ Sludge ☒ **Debris** ☐ Grease  
Silt Depth: **7** (in.) Deposits Extent: **Medium**  
Infiltration: **None** Pipe Seal Cond: **Sound**
